USAAVLABS TECHNICAL REPORT 68-51

AN EVALUATION OF ARMORED AIRCREW CRASH SURVIVAL SEATS

July 1968

**CONTRACT DAAJO2-68-C-0027
DYNAMIC SCIENCE
DIVISION OF MARSHALL INDUSTRIES
PHOENIX, ARIZONA**

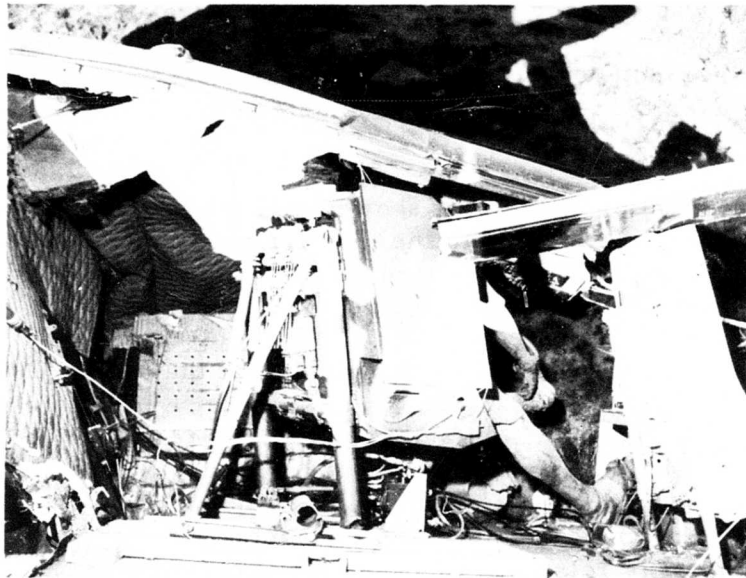
Postcrash inspection of the seat showed that the forward support tubes had failed at their junction with the forward cross tube, as shown in Figures 7 and 8. None of the energy absorbers had stroked, indicating that failure had occurred below their design load.

Figure 7. Postcrash Side View of Armored Survival Seat. Note Failure of Forward Support Tubes.

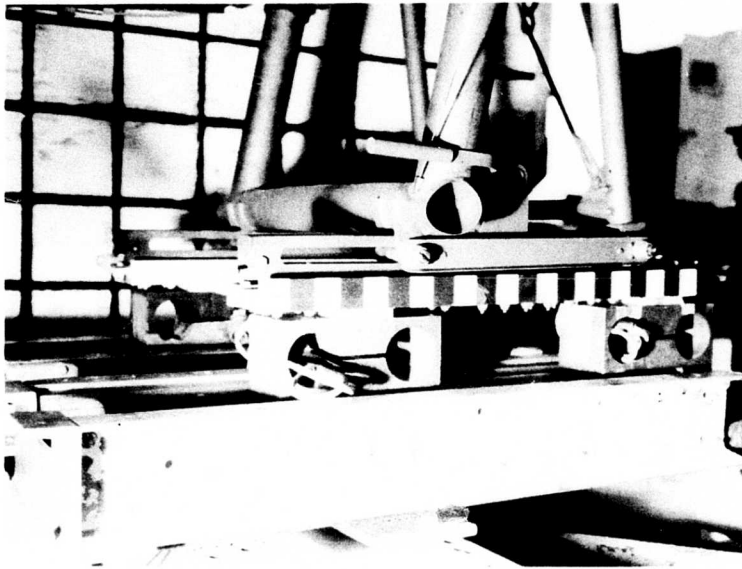
The load was increased to 7,800 pounds, at which point the front cross tubes buckled at their junction with the forward support tubes. The longitudinal energy absorbers did not stroke. Figure 11 shows the failed cross tube.

Figure 11. Failure of Front Cross Tube During Longitudinal Static Test.

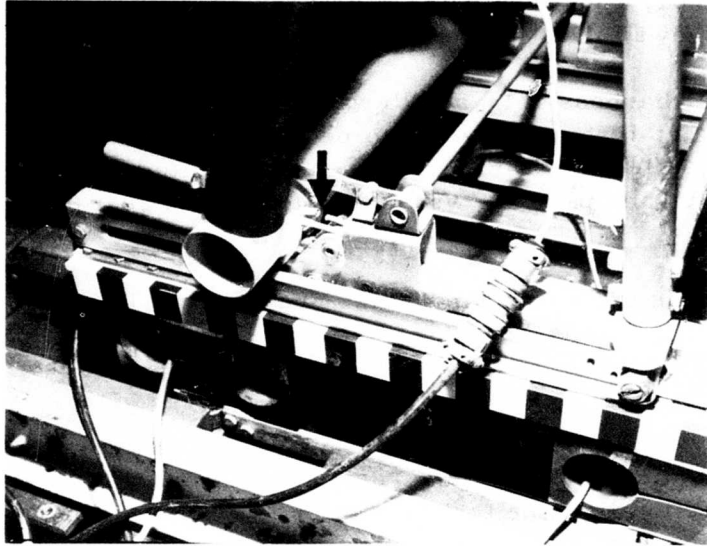
Following this test, a second longitudinal static test was conducted using a seat manufactured by Hayes International Corporation. To avoid the possibility of stressing the restraint harness beyond its design limits, the seat bucket was removed and the load was applied through a frame fabricated to fit in place of the seat bucket. In the initial test of this seat, the left inboard energy absorber rod failed at the weld joining the rod to its threaded fastener end. This failure occurred when a load of 4,600 pounds was applied to the seat frame. Figure 12 shows this failure.

Figure 12. Failed Energy Absorber Rod
on Hayes-Built Seat.

This rod was replaced and the test was repeated. At a load of 9,000 pounds, the energy absorbers began to stroke. No failures of the seat frame occurred. From the results of these three static tests, it was concluded that the USAAVLABS-built seats were weak at the juncture of the forward support tubes with the front cross tubes. This weakness was due to either improper heat-treating of the parts or improper welding techniques.

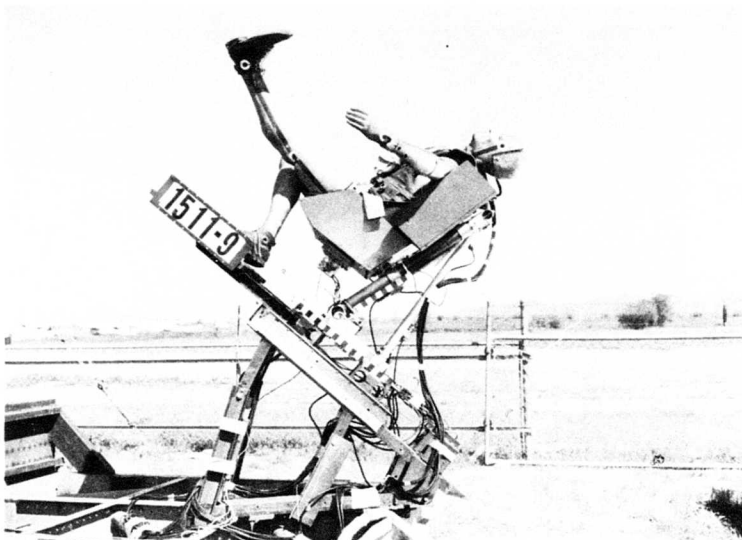
of 46.2 feet per second. No seat damage occurred. The vertical energy absorber stroked 2.72 inches, while the longitudinal and lateral energy absorbers did not stroke. The high seat-pan and occupant pelvic accelerations in the vertical axis reflect the limited energy absorber travel. These vertical accelerations were approximately in phase with the vertical input pulse, particularly during the early part of the pulse.

The reversal in the longitudinal seat-pan acceleration was probably caused by the release of a rear tiedown bolt on the seat mount. At the peak of the input pulse this bolt came free, allowing the seat mount to flex upward and forward.

Figure 38. Posttest Side View - Test 9.

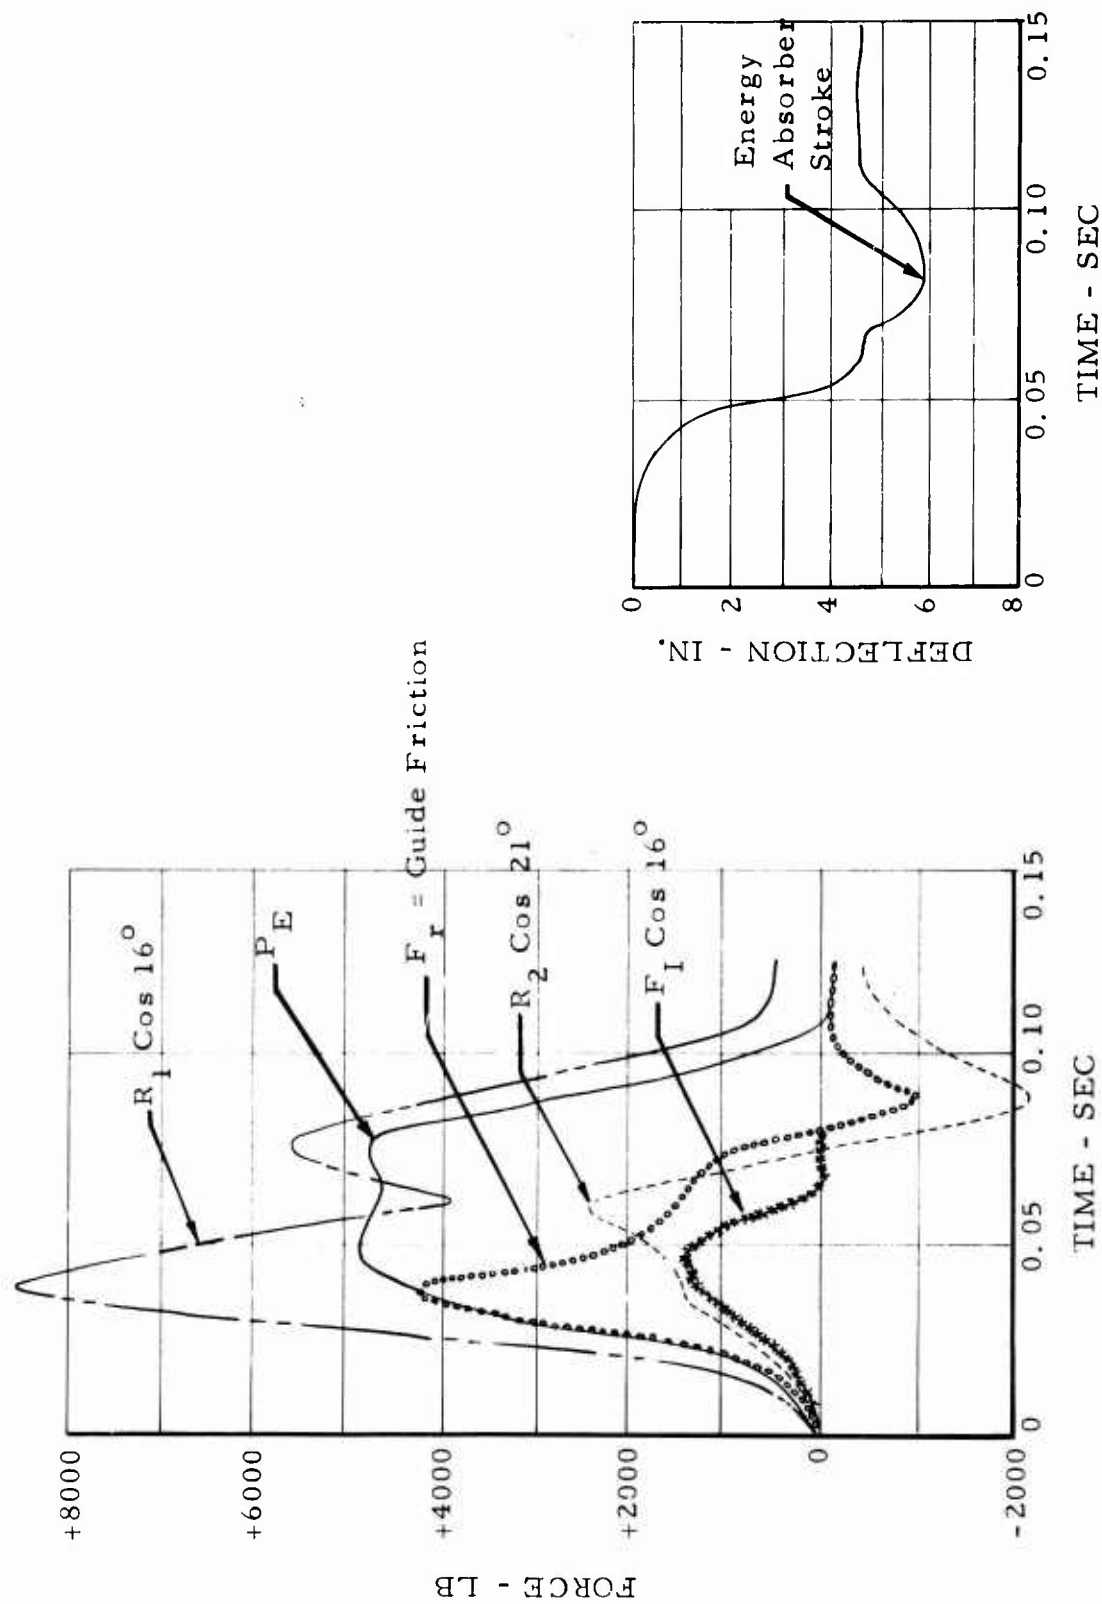
The friction load increased to approximately 4,200 pounds at 0.037 second and then dropped to 2,000 pounds as maximum stroking rate occurred at 0.05 second. The friction force reduced to zero at 0.08 second, at which time the absorber stroke was completed and rebound started. Approximately 1 inch of rebound occurred, during which the friction force was reversed with respect to the direction shown in Figure 40. The friction force thus remained in opposite direction to the relative motion of the two mating parts.

Figure 41. Friction Load in the Seat Pan Guide - Test 2.

It should be noted that the peak friction force (4,200 pounds) is almost equal to the peak energy absorber load (4,700 pounds). As a result, the load being applied to the seat pan is almost double that of the desired load. Obviously, a suitable means must be found to eliminate this variable friction force. One solution would be the use of linear bearings or rollers in the guide system. In fact, one of the four original seat designs referred to in the Introduction of this report used a roller guide system. Caution must be exercised on the part of the seat designers to

make certain that the movable part of the energy absorbing seat system not only is free of friction but strokes smoothly without variable resistance. This must occur when the seat is subjected to all anticipated loads, even though distortion of the seat pan guide system occurs. Such distortion occurs in the form of bending of the guide rails and torsion and shearing deformations due to lateral loads and floor buckling. Close-fitting seat-pan guide systems (as in the Hayes seat tested in this project) should be expected to bind and/or experience excessive frictional forces when subjected to these loading conditions.
